# Electrical Safety Audit Report

**Bank Ltd.**

**SAS Powertech Pvt Ltd.**

**Audit Period: 2018**

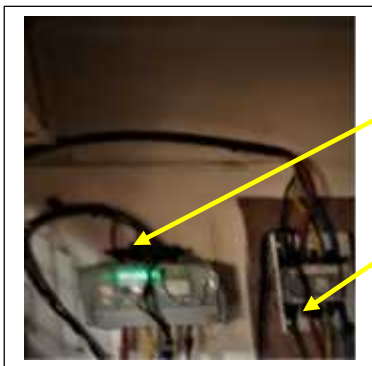
- 2) Main MSEDCL INPUT is received, metered and distributed on wall mounted switchgear. We recommend a well-designed metal cabinet in place of present wooden box. Cables laid on wall do not have proper supports and strain relievers.

Incoming cable coming to meter not supported

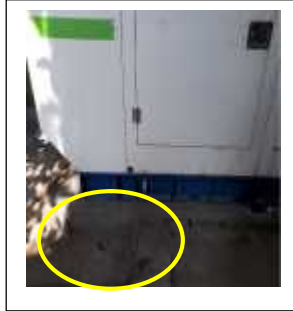
- 4) As per CEA 2010 guidelines, earth pit resistance test report must be maintained as record at branch. These tests should be carried out at least once in a year. This is also important from data security point of view as UPS output needs proper earthing.

Earth pits for MSEDCL earthing and DG set earthing do not have identifiers, It is not possible to disconnect electrode from Grid so individual pit cannot be checked.

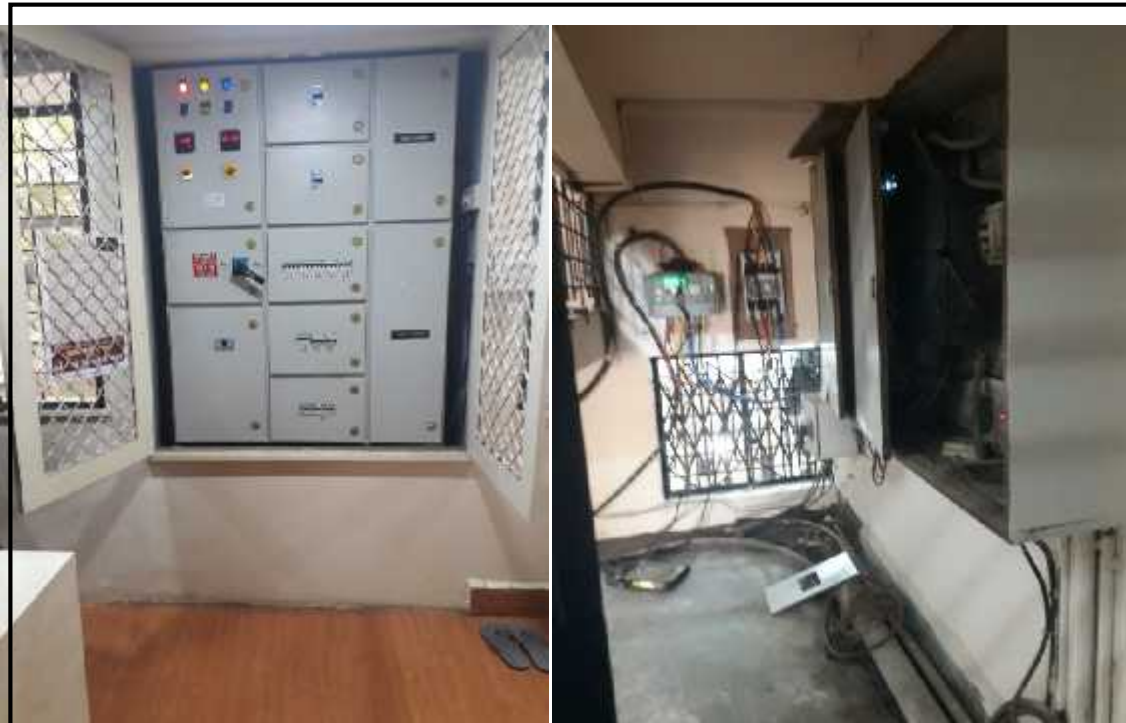
- 8) During Physical inspection of the facility it is observed that Rubber/Insulating mats are not provided in front of distribution panels. As per provisions in CEA 2010, it is recommended to provide the rubber mats of suitable size & rating as per IS: 15652-2006 as amended.

Rubber Mats are not provided in front of LT panels. Main electrical input cables are not terminated and secured properly.

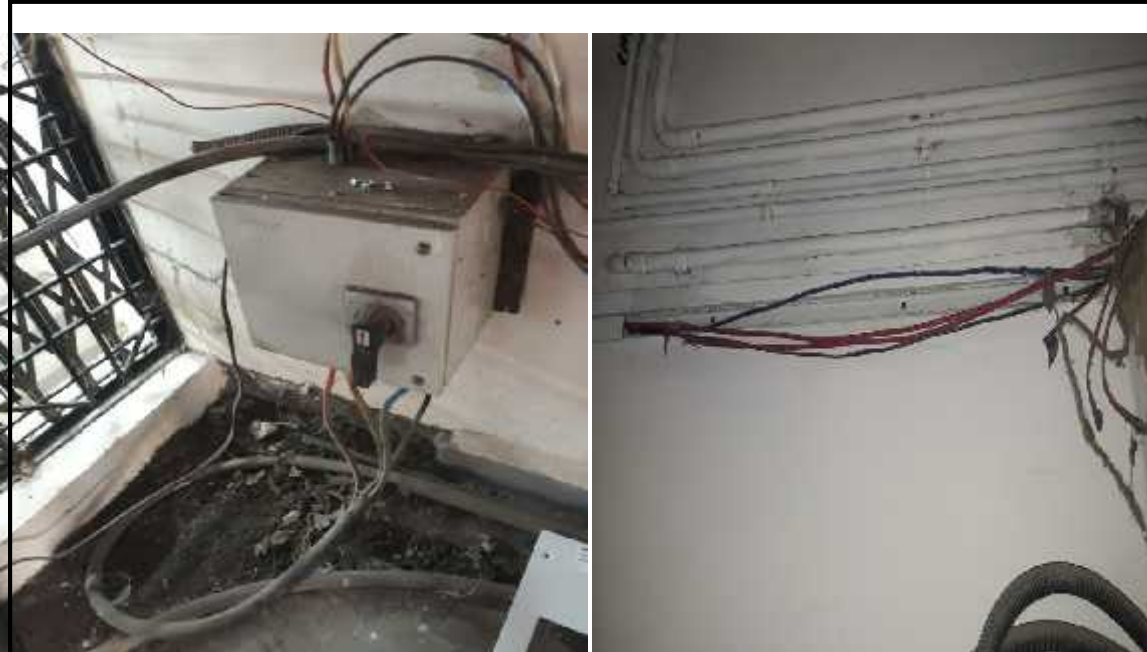
DG change over switch is mounted on wall and cabling is improper. There is possibility of damage due to rodents. Inside some cables are brought out of casing capping are joined improperly.

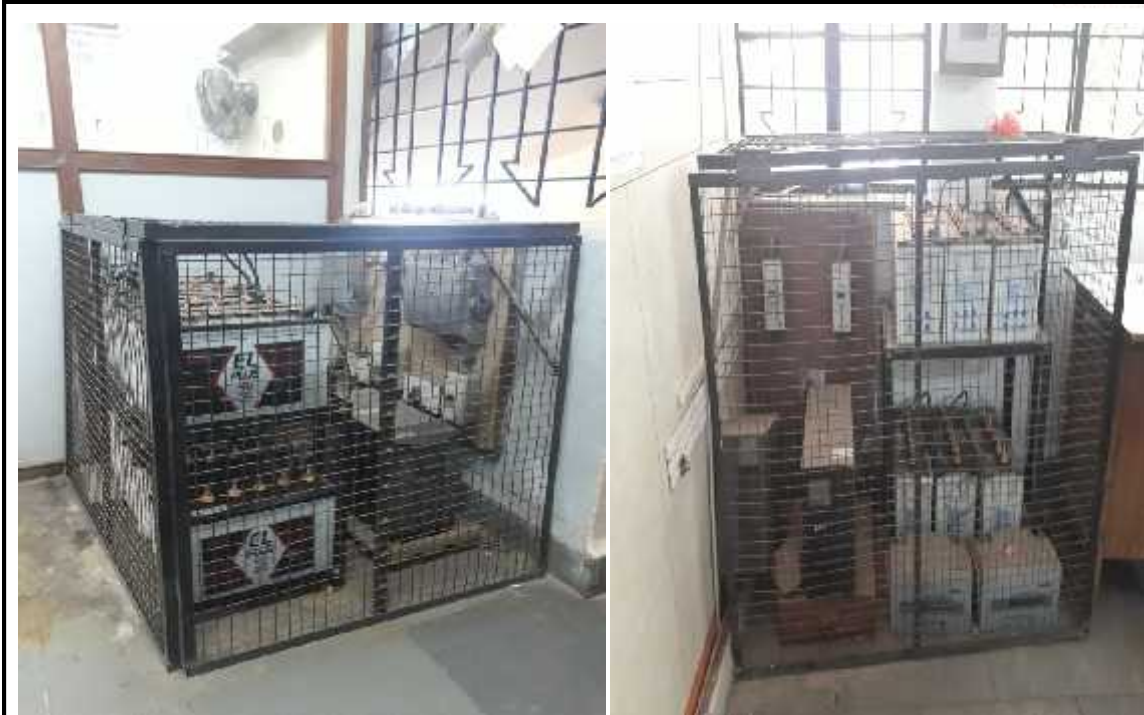
UPS installed for Branch & ATM are well protected & are not accessible for layman. Provision should be made for hydrogen exhaust using exhaust fans.

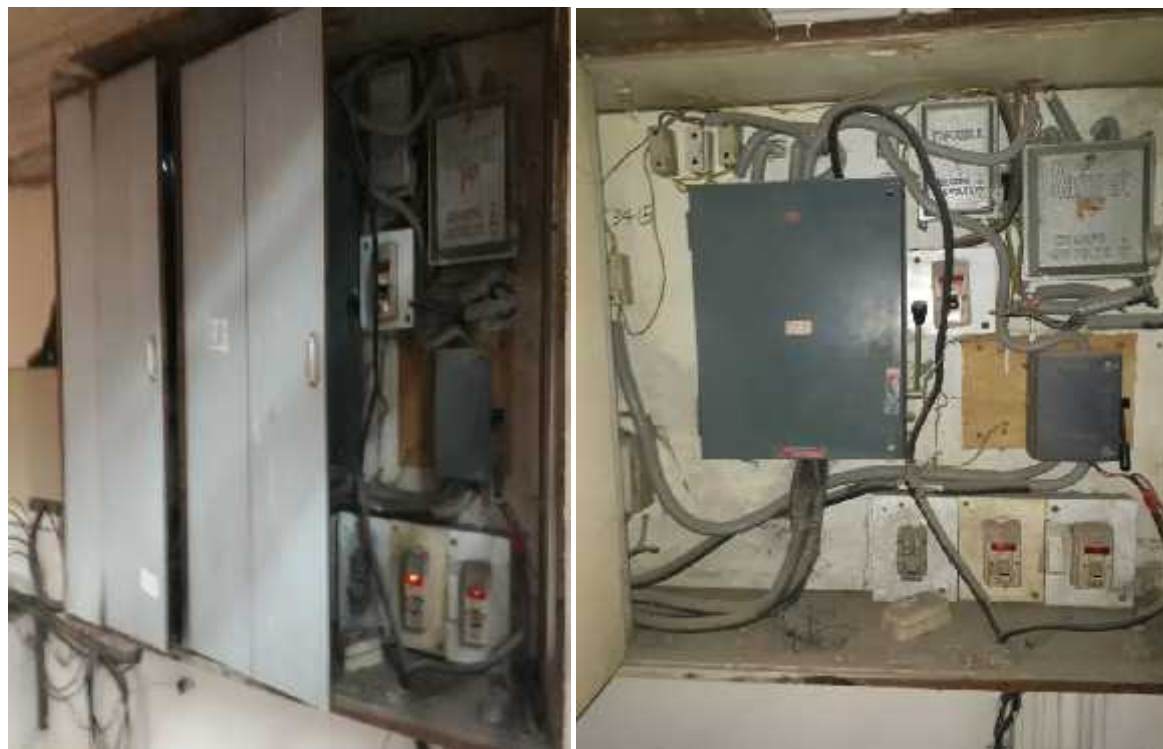
Distribution Boards & Fuse units are installed on wooden board which may catch fire during fault. It is recommended to use metal DB in place of existing wooden board.

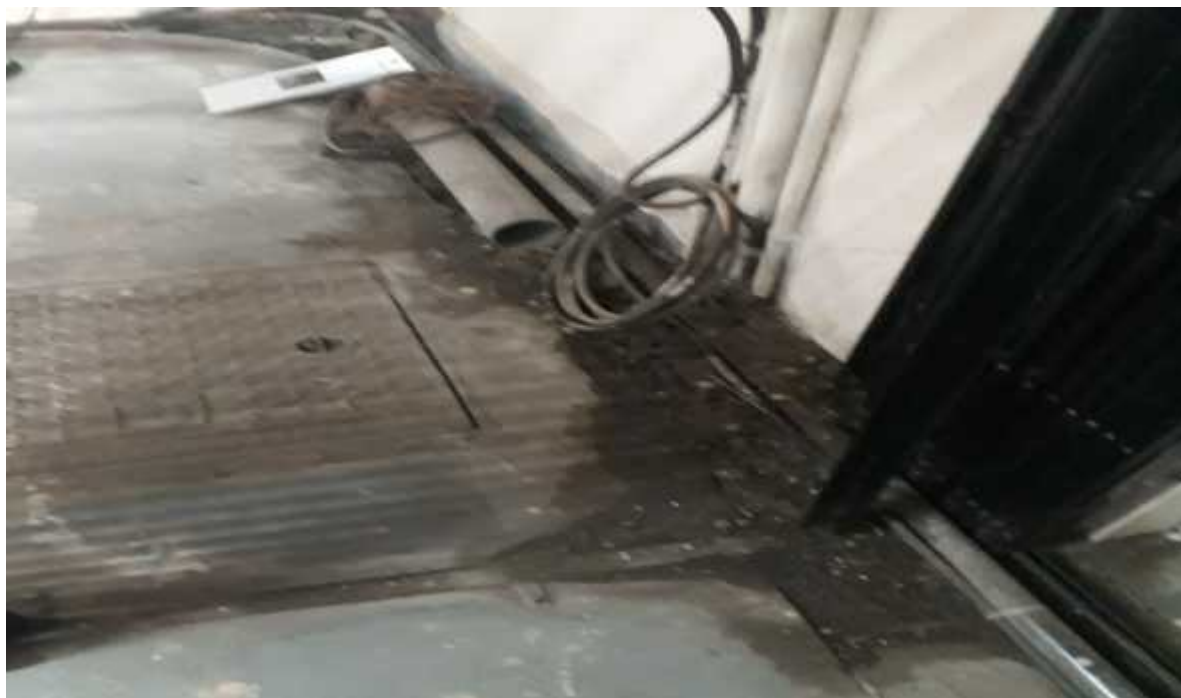
Main DB and changeover switch at ground floor are installed above underground water storage tank. This tank frequently overflows. This is a potentially dangerous situation. Corrective actions should be taken to keep this place dry to lower a risk of electric shock or electrical incident.

| Sr. No | Regulation No. | Requirements | Report |
|---|---|---|--|
| | | Any other General remark | Main DB and changeover switch at ground floor are installed above underground water storage tank. This tank frequently overflows. Care should be taken so that this water does not cause trouble. Other wooden boxes and wall mounted switchgears and meters should be housed in sheet metal box with proper earthing. |

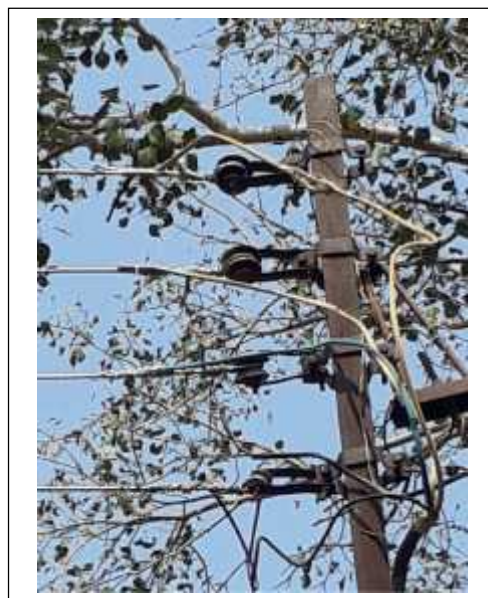
- 1) This Branch uses LT connection from MSEDCL. which comes with **Neutral** from pole. Breaking of Neutral results into very high single phase voltages and the same is dangerous for data centre loads. It is observed that this happens occasionally as the same is under maintenance of MSEDCL. We recommend, a **DELTA - STAR** isolation transformer of required capacity with STAR point of secondary to be properly earthed at bank premises and the same to be used as NEUTRAL inside the bank.

This is the pole from which bank LT electric supply is tapped. The joints at present are in good condition. This overhead line is property of MSEDCL and may get tapped for other consumers and there is possibility of neutral failure.
