HARMONIC ANALYSIS REPORT

Post Filter Installation

Leading Gear Manufacturing

Audit Date: 12 Oct 2018

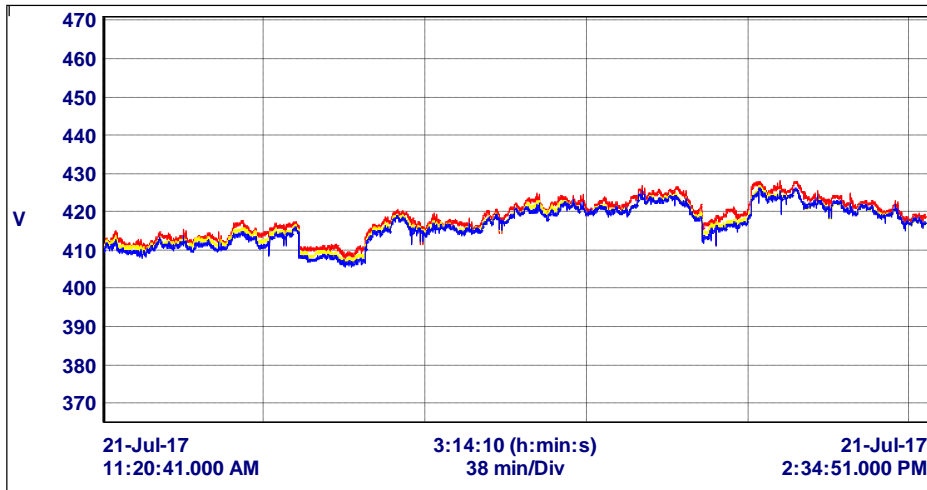
Voltage (Before)

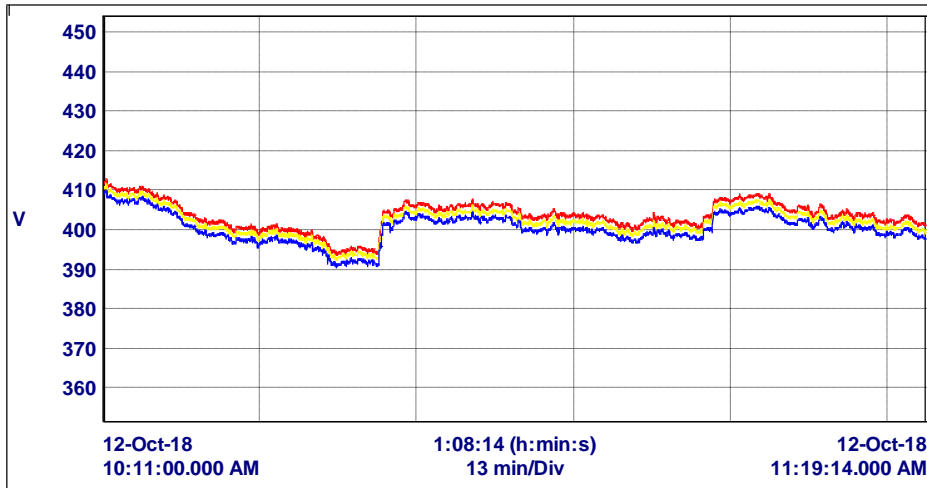
Voltage (after)

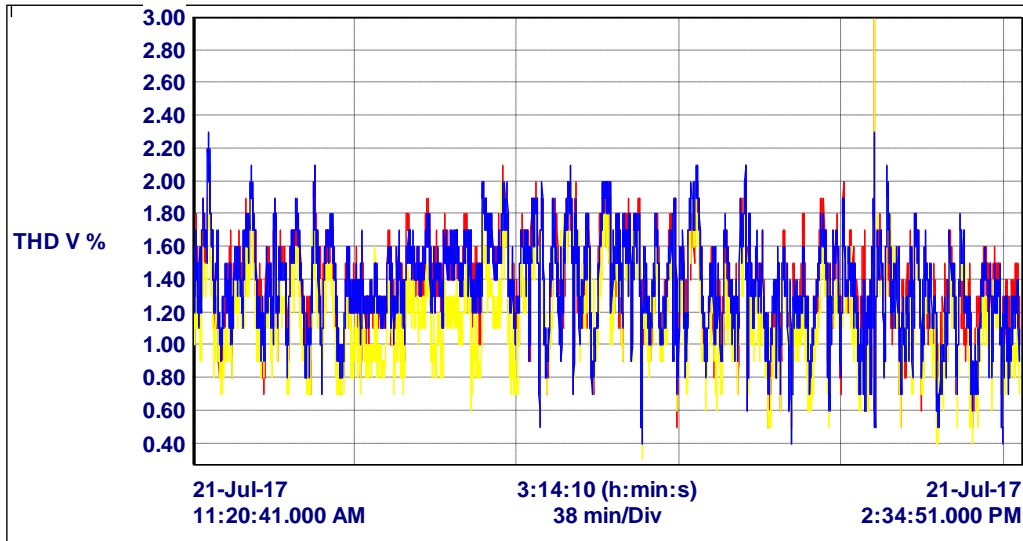
Voltage harmonic distortion. (Before)

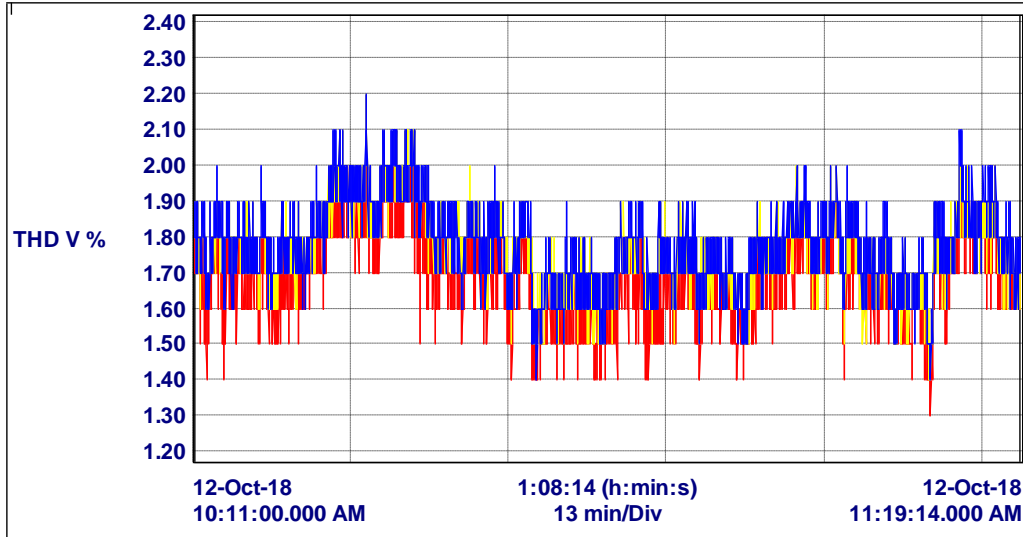
Voltage harmonic distortion. (After)

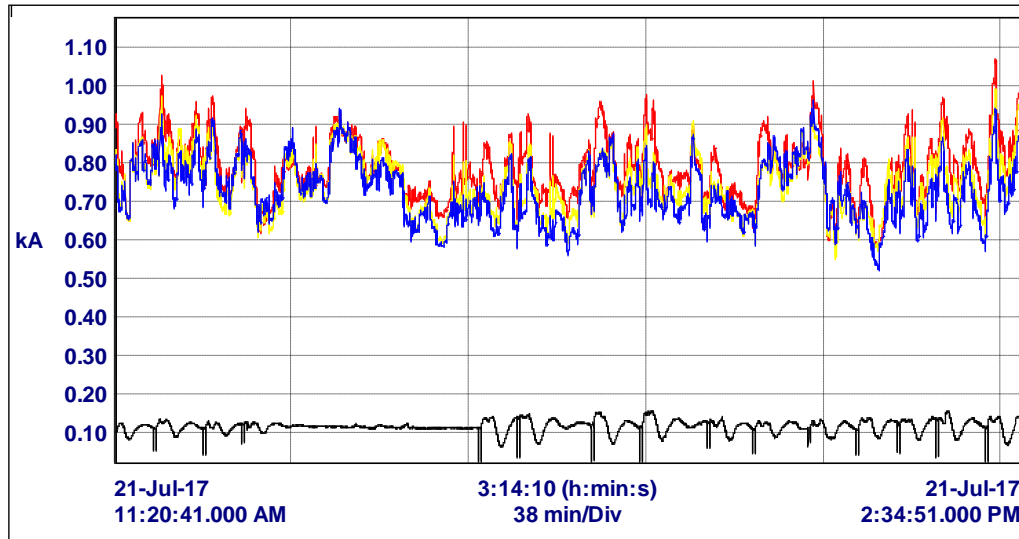
Current – As demanded by Load (Before)

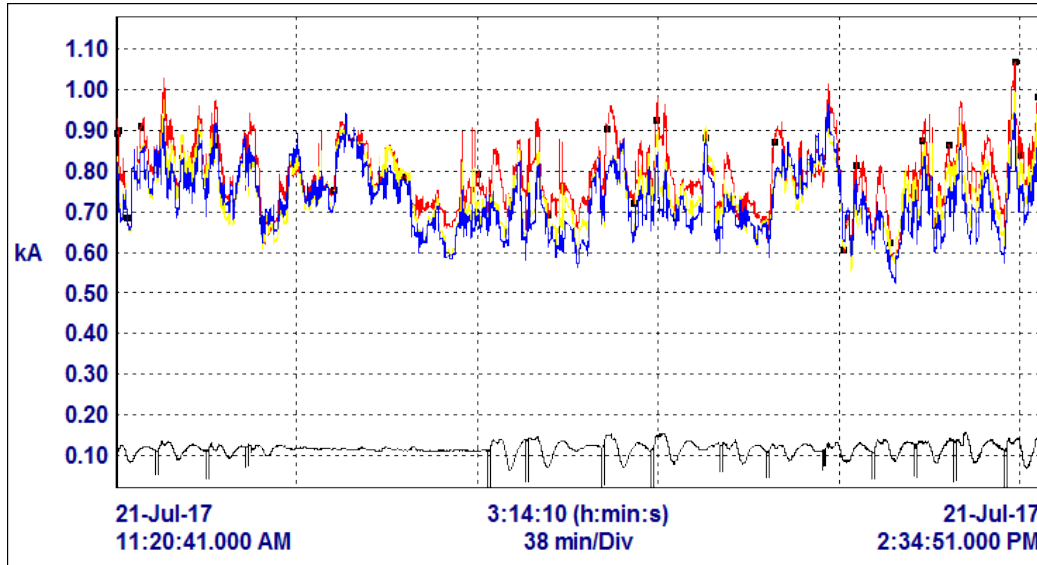
Current – As demanded by Load (After)

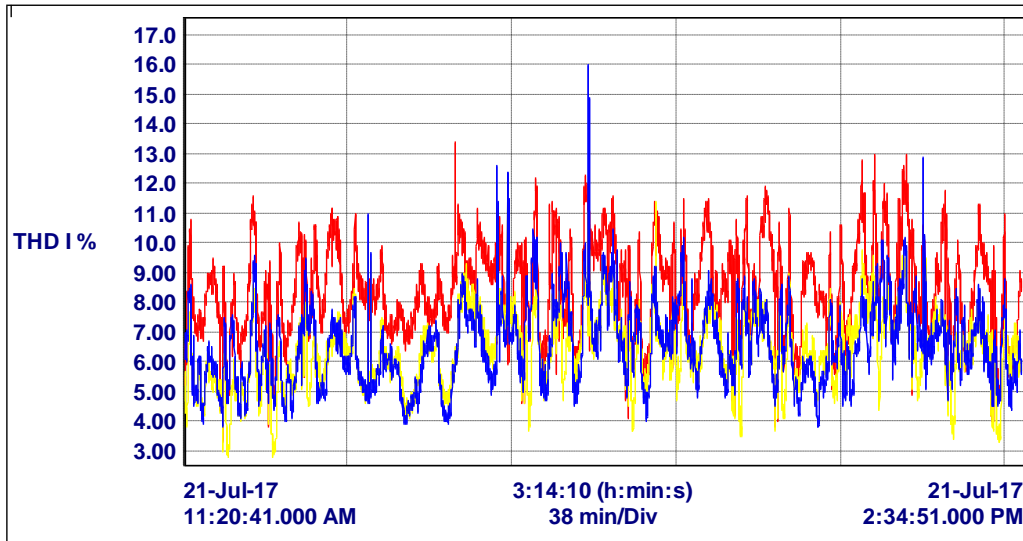
Current harmonic distortion (before)

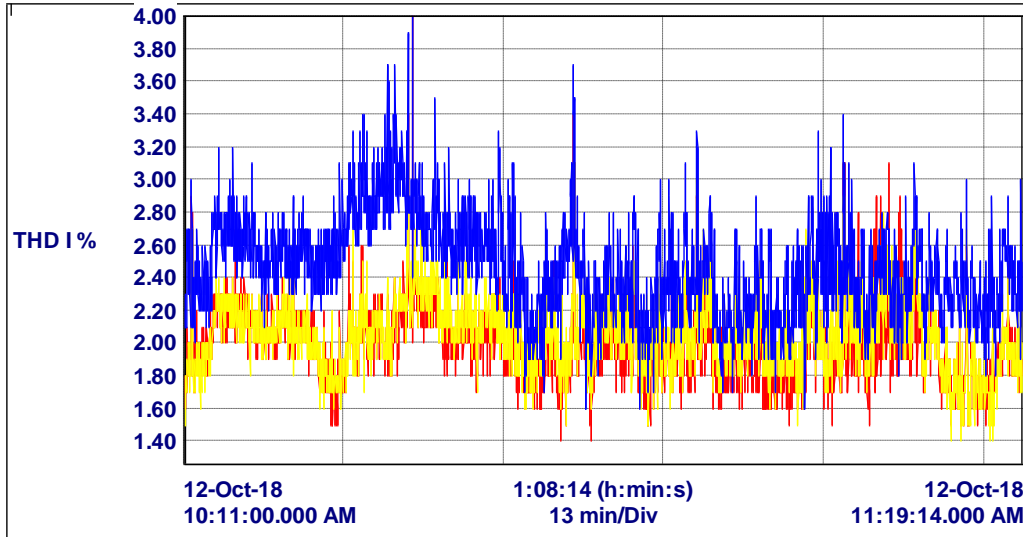
Current harmonic distortion (After)

Current Harmonic Distortion Reduced from 16% to 3.8%

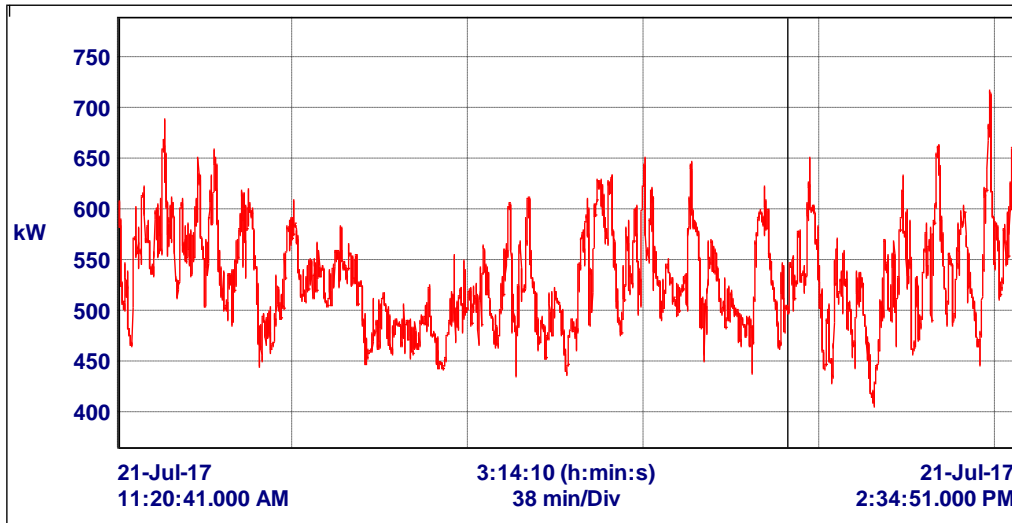
KW Load Before

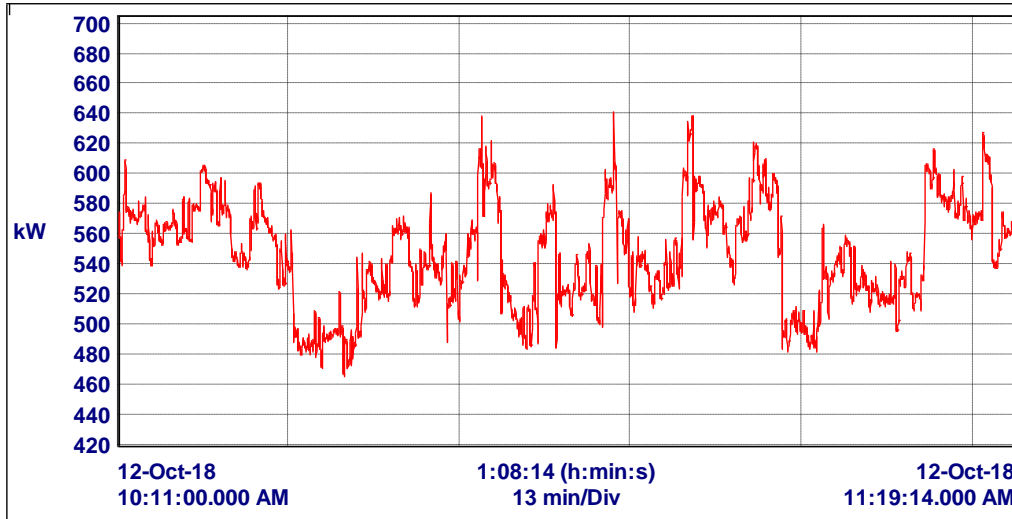
KW Load After

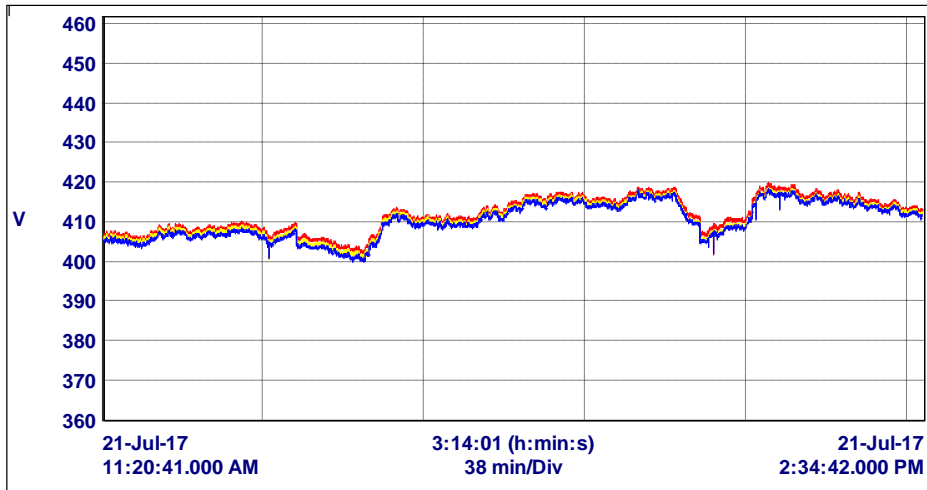
Voltage (Before)

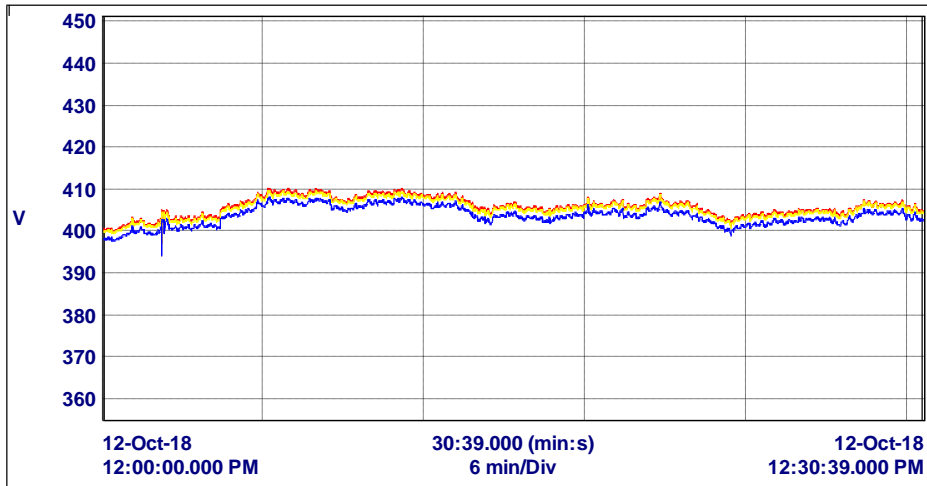
Voltage (after)

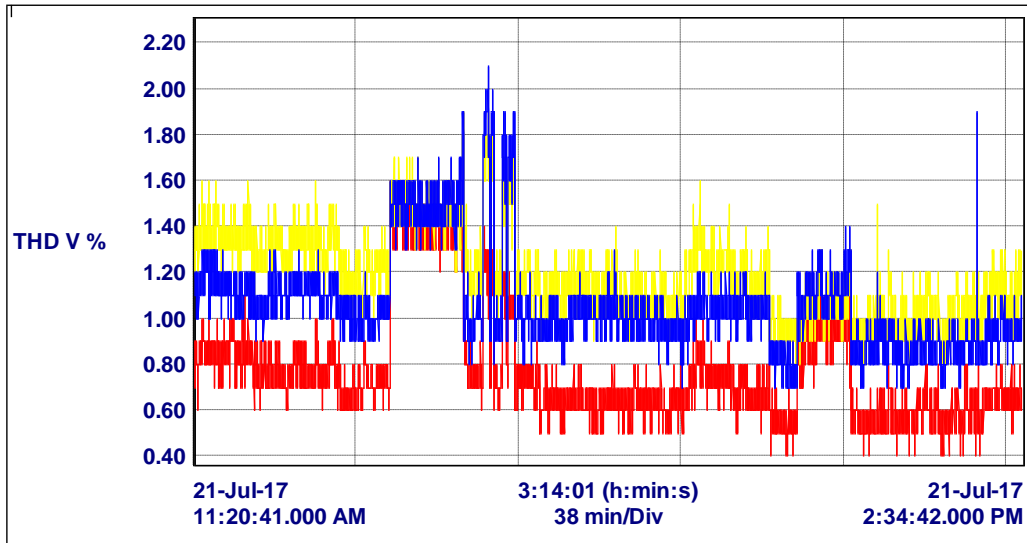
Voltage harmonic distortion. (Before)

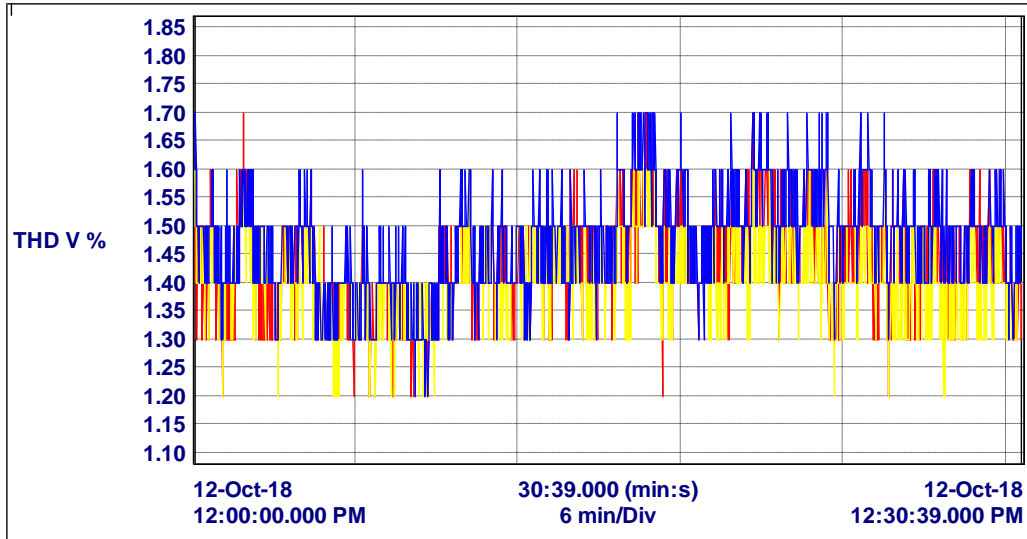
Voltage harmonic distortion. (After)

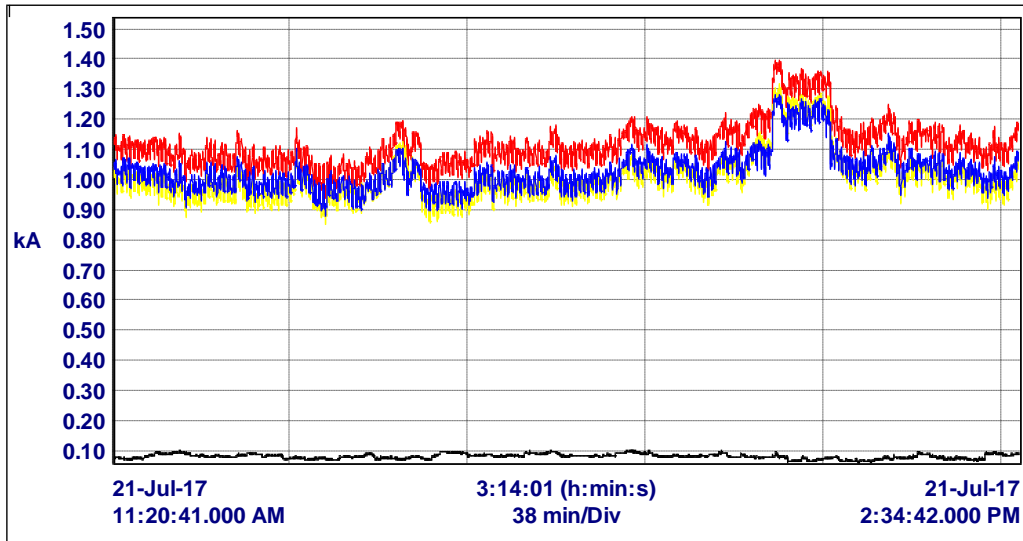
Current – As demanded by Load (Before)

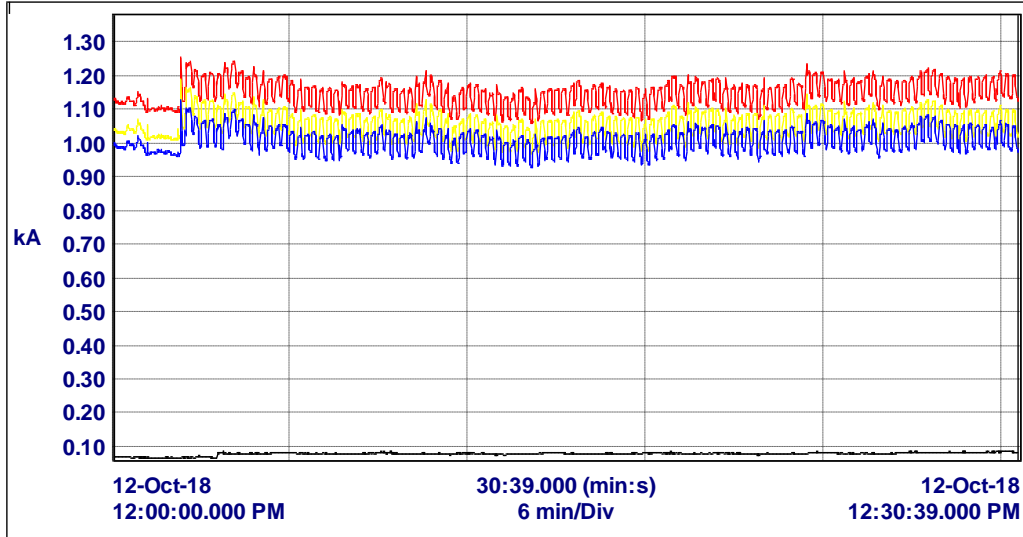
Current – As demanded by Load (After)

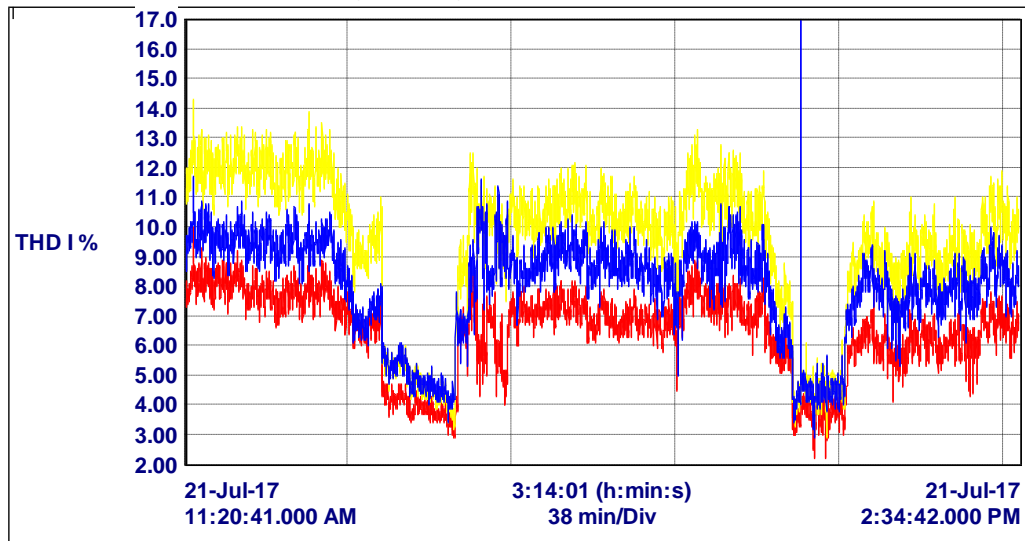
Current harmonic distortion (before)

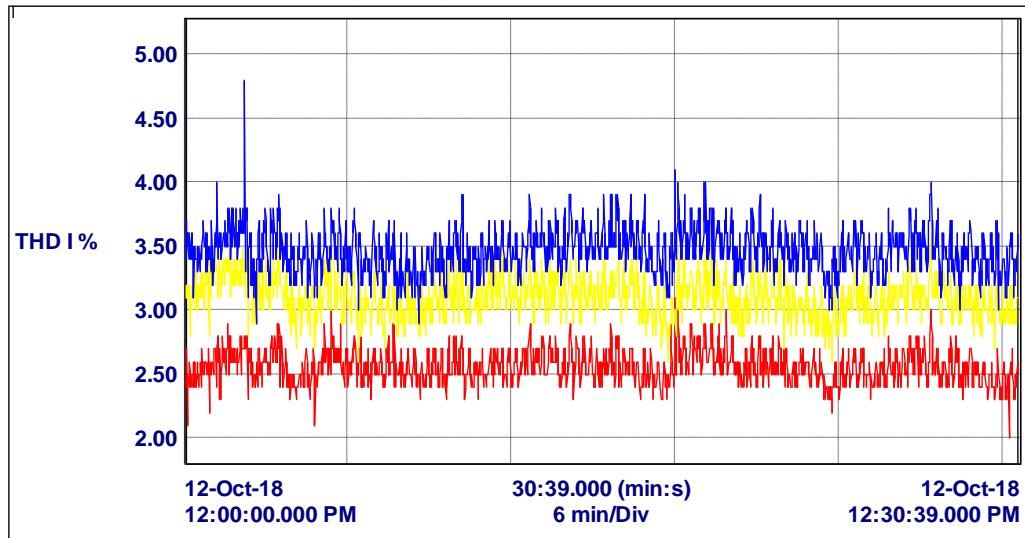
Current harmonic distortion (After)

Current harmonic distortion – Reduction to 14% from 4%

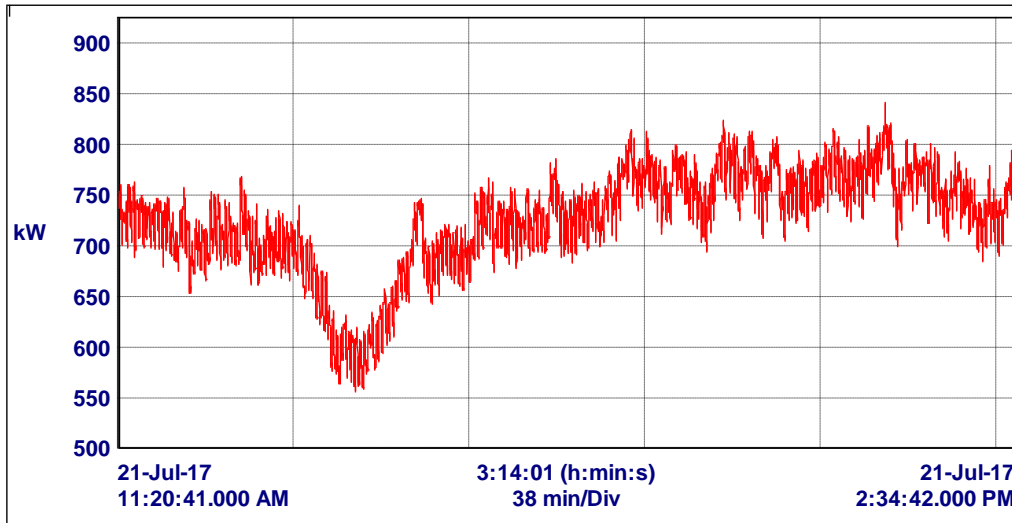
KW Load Before

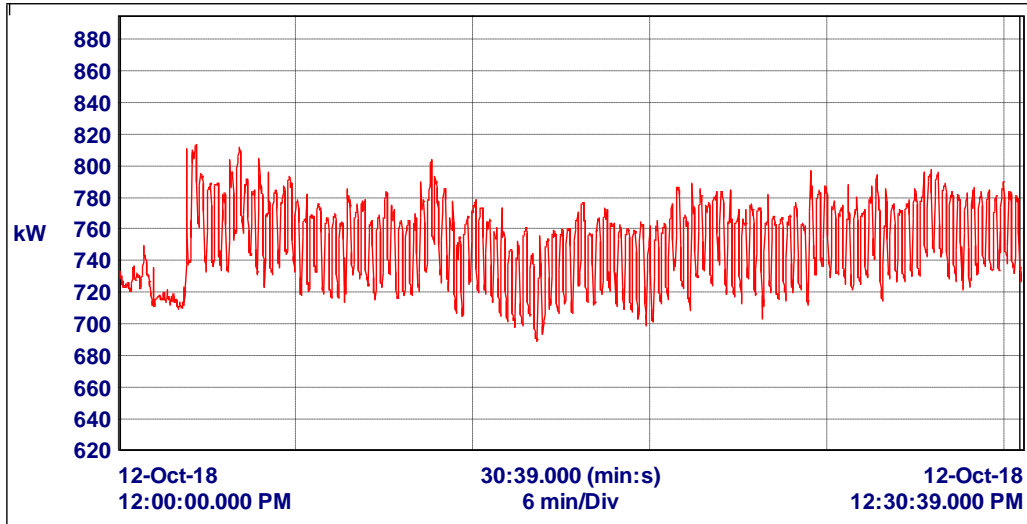
KW Load After
