Company Sas Powertech Pvt. Ltd. Tester :
Mr. Abhijit Katre
Phone: 020-25533015
E-Mail: solutions@saspowertech.com

Task Thermographic analysis of electrical system

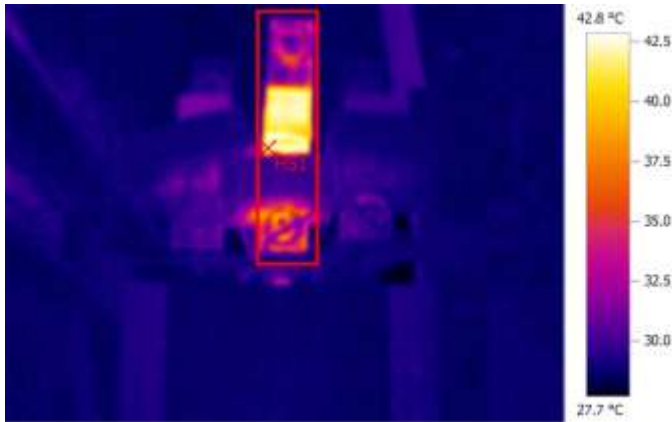
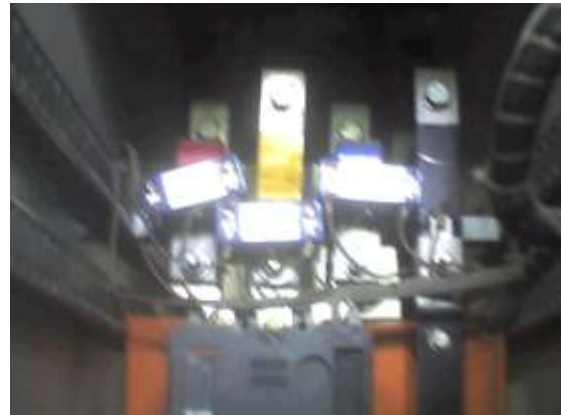
IV_03880.BMT

Measurement Objects	Temp. [°C]	Remarks
Hot spot 1	42.8	-

Equipment: Main LT Panel/ Feeder- 3F1 (Utility Panel)

Findings: Marked Y-Phase outgoing busbar of switch may be loose at termination

Repair priority: 2 (Repair soonest possible)

Recommendations: Inspect, clean & tight connection at terminals and related components.

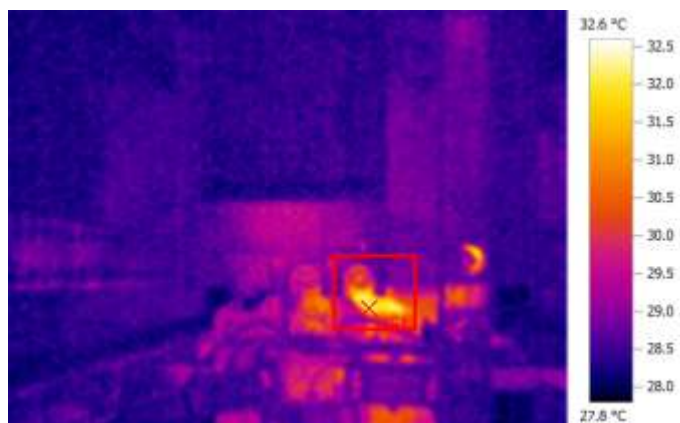
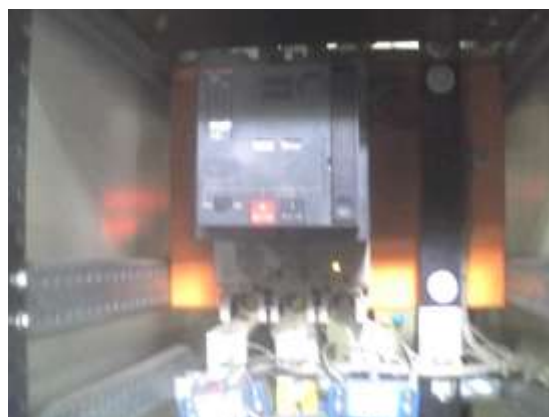
IV_03881.BMT

Measurement Objects	Temp. [°C]	Remarks
Hot spot 1	32.6	-

Equipment: Main LT Panel/ Feeder- 5F2 (Nexplicit)

Findings: Marked B-Phase incoming busbar termination at switch may be loose.

Repair priority: 2 (Repair soonest possible)

Recommendations: Inspect, clean & tight connection at terminals and related components.

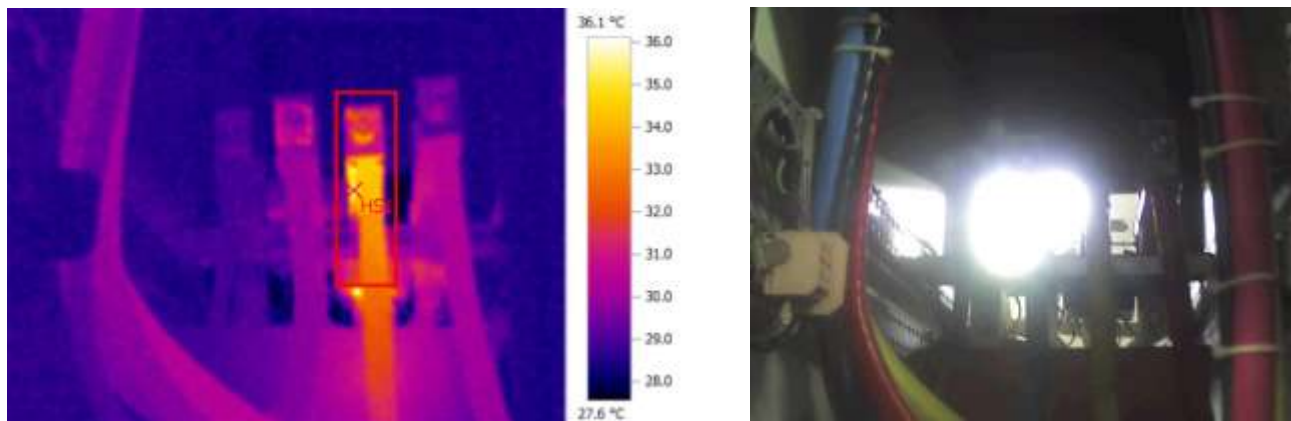
IV_03886.BMT

Measurement Objects	Temp. [°C]	Remarks
Hot spot 1	36.1	-

Equipment: Main LT Panel/ Feeder- 3F1 (Utility Panel) Cable Chamber

Findings: Crimping of marked Y-Phase outgoing cable may be loose.

Repair priority: 2 (Repair soonest possible)

Recommendations: Inspect, clean & tight connection at terminals and related components.
Also re-crimp or replace cable lug if required.

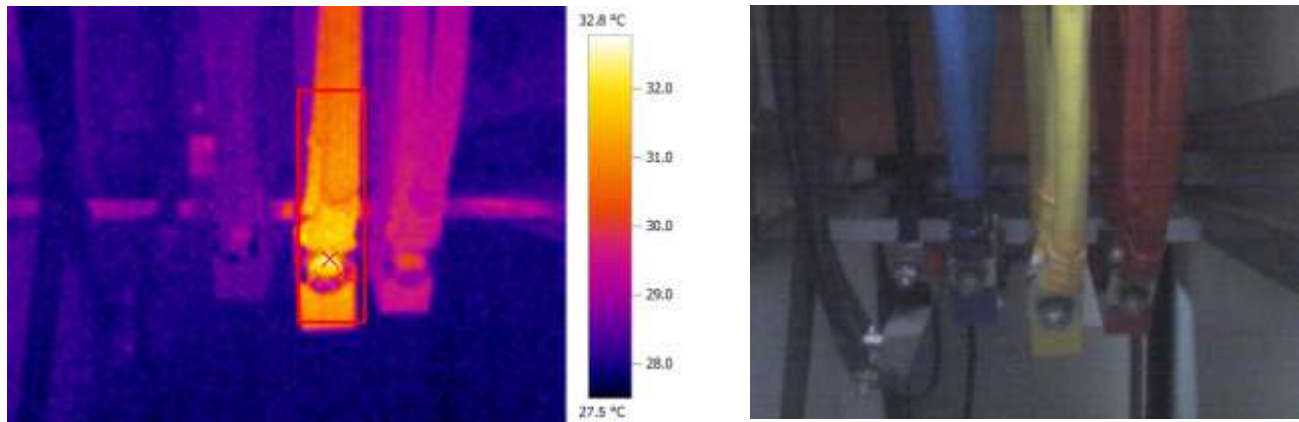
IV_03887.BMT

Measurement Objects	Temp. [°C]	Remarks
Hot spot 1	32.8	-

Equipment: Main LT Panel/ Feeder- 9F2 (Kone Crane) Cable Chamber

Findings: Crimping of marked Y-Phase outgoing cable may be loose.

Repair priority: 2 (Repair soonest possible)

Recommendations: Inspect, clean & tight connection at terminals and related components.
Also re-crimp or replace cable lug if required.

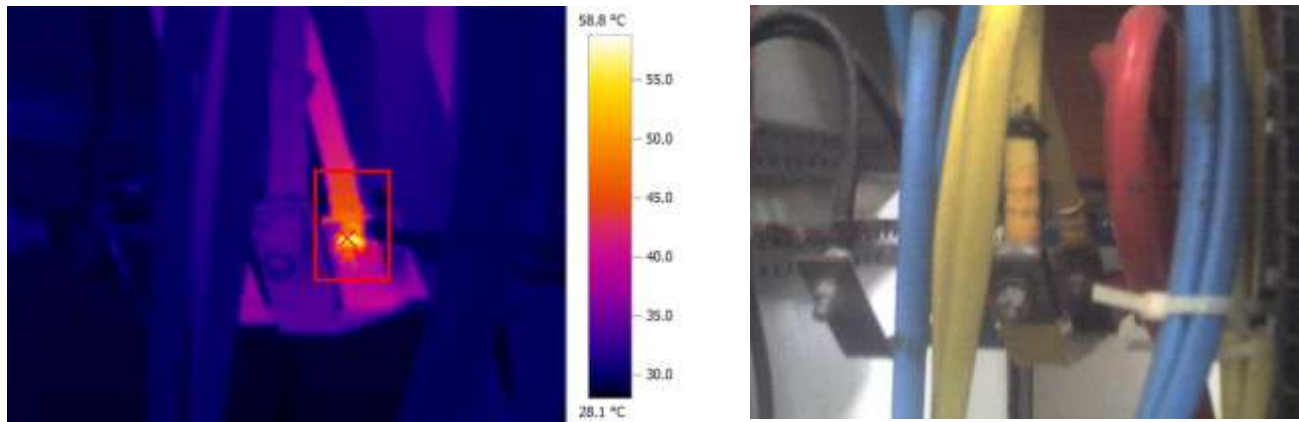
IV_03888.BMT

Measurement Objects	Temp. [°C]	Remarks
Hot spot 1	58.8	-

Equipment: Main LT Panel/ Feeder- 10F2 (Marvell-3)

Findings: Marked Y-Phase outgoing cable termination may be loose.

Repair priority: 2 (Repair soonest possible)

Recommendations: Inspect, clean & tight connection at terminals and related components.

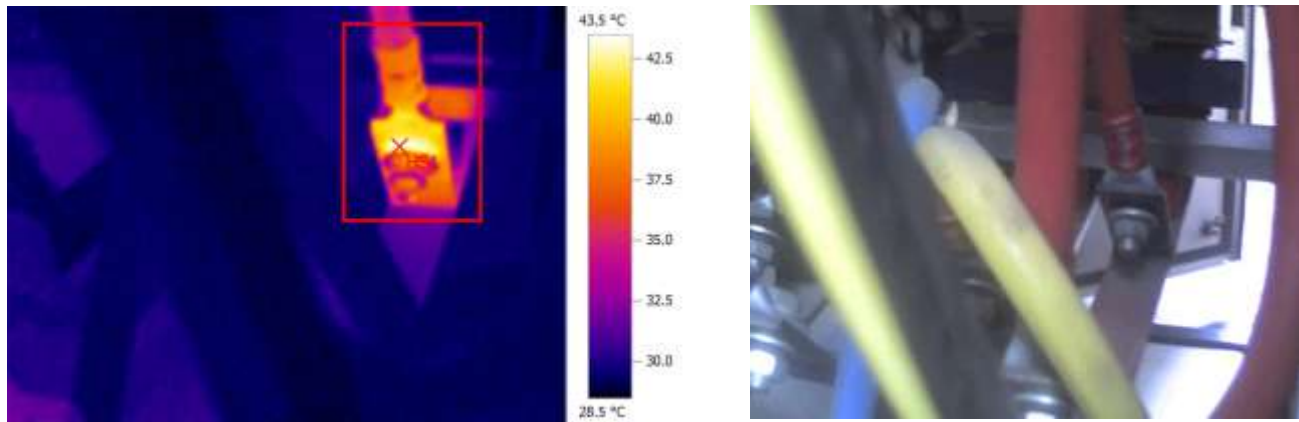
IV_03889.BMT

Measurement Objects	Temp. [°C]	Remarks
Hot spot 1	43.5	-

Equipment: Main LT Panel/ Feeder- 21F2 (Marvell-2)

Findings: Marked R-Phase outgoing cable termination may be loose.

Repair priority: 2 (Repair soonest possible)

Recommendations: Inspect, clean & tight connection at terminals and related components.

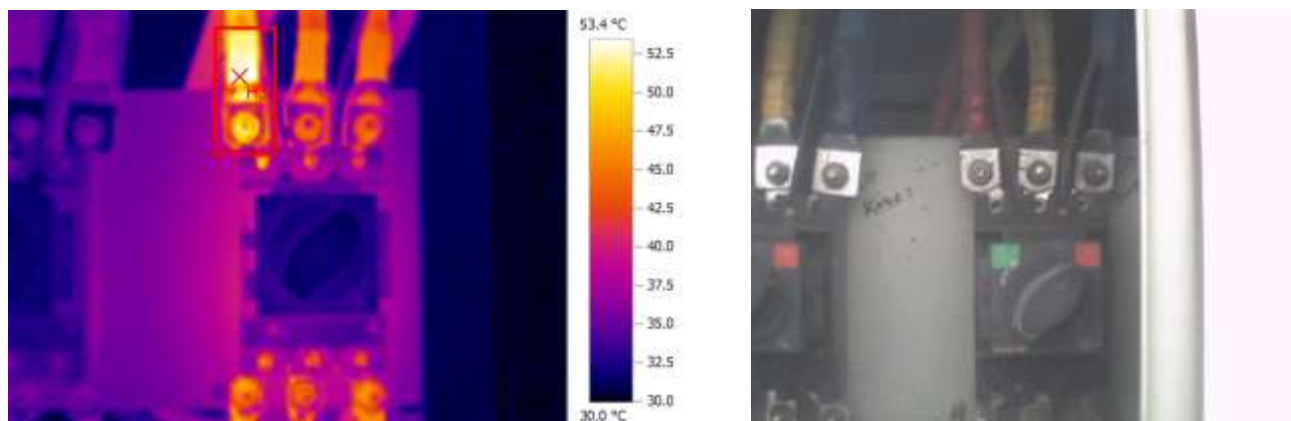
IV_03893.BMT

Measurement Objects	Temp. [°C]	Remarks
Hot spot 1	53.4	-

Equipment: Commercial Tenant Panel/ Kone-2 Feeder

Findings: Crimping of marked R-Phase outgoing cable may be loose.

Repair priority: 2 (Repair soonest possible)

Recommendations: Inspect, clean & tight connection at terminals and related components.
Also re-crimp or replace cable lug if required.

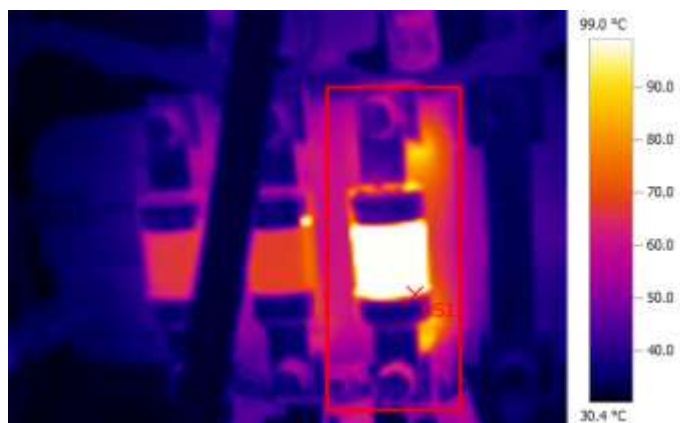
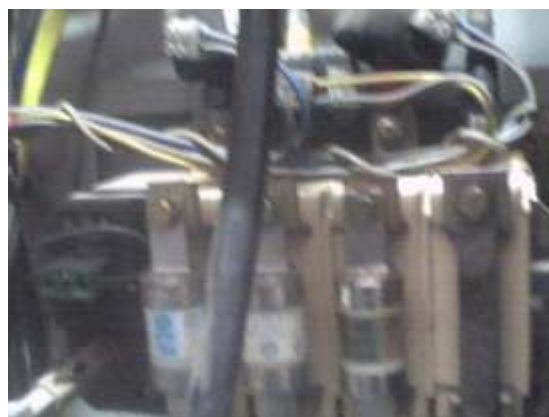
IV_03894.BMT

Measurement Objects	Temp. [°C]	Remarks
Hot spot 1	98.0	-

Equipment: Commercial Tenant Panel/ Texas Feeder

Findings: Marked R-Phase fuse over heated

Repair priority: 1 (Repair immediately)

Recommendations: Inspect, clean & tight connection at terminals and related components.
Also replace fuse if required.

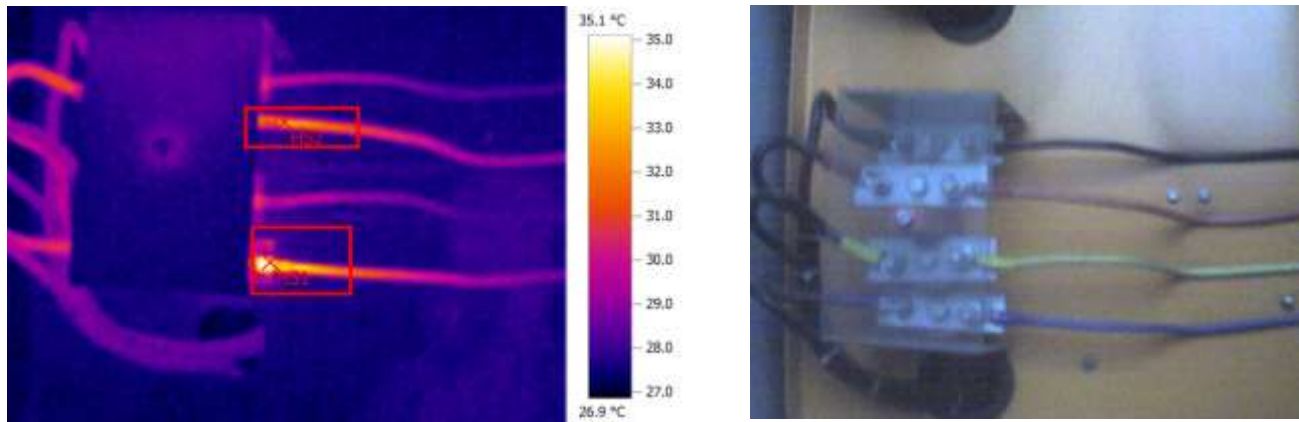
IV_03895.BMT

Measurement Objects	Temp. [°C]	Remarks
Hot spot 1	35.1	-
Hot spot 2	33.0	-

Equipment: Lighting DB

Findings: Crimping of marked R & B-Phase outgoing cable lugs may be loose

Repair priority: 2 (Repair soonest possible)

Recommendations: Inspect, clean & tight connection at terminals and related components.
Also re-crimp or replace cable lugs if required.
