Electrical System Study & Validation Audit

XXXXXXXXXX Ltd

Aaaabbbbccccdddd Nagpur

Audit Period: July 2018

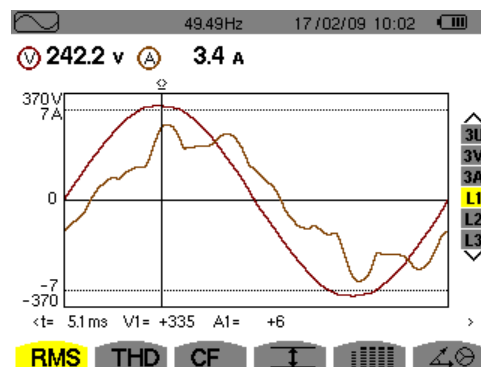
Non linear loads like computer power supplies, VFDs, UPS systems, electrical arc furnaces, Plating rectifiers, and Battery chargers take non sinusoidal current while sinusoidal voltage is applied to them. This is shown in waveforms bellow.

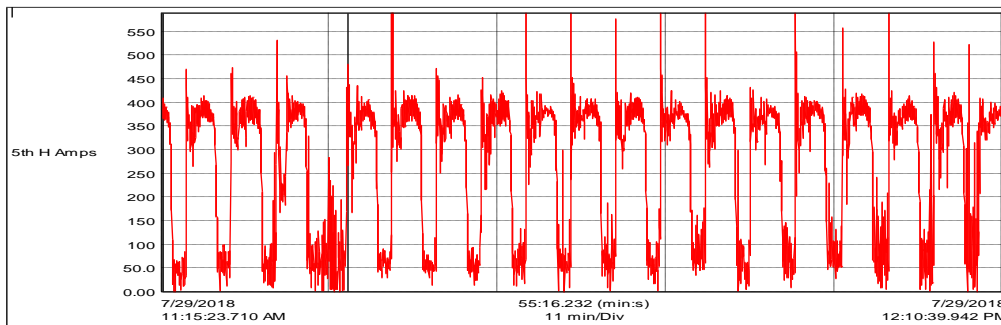
- The pattern of 5th harmonic current in LBB1 load is as follows:

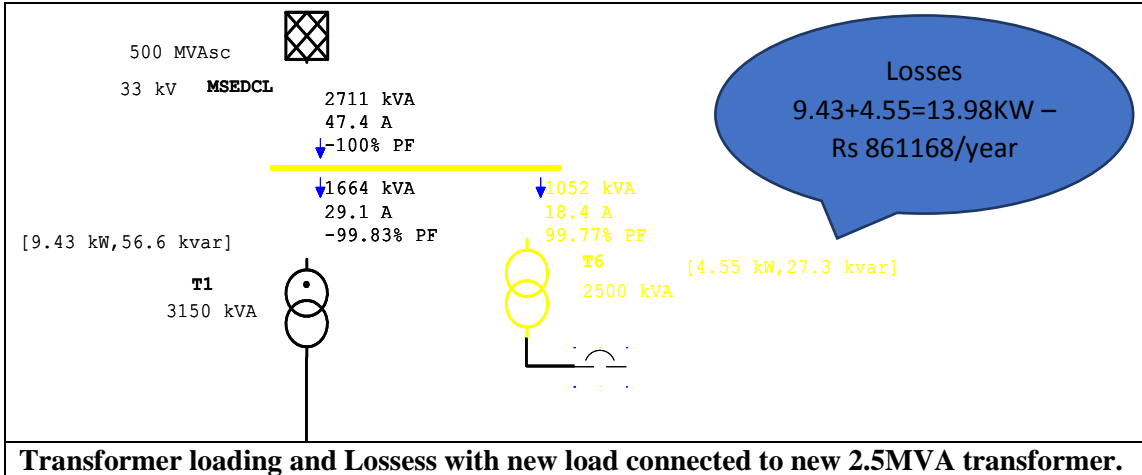
Table 2

</p> <p>33 kV MSEDCCL</p> <p>[15.6 kW, 93.3 kvar]</p> <p>T1 3150 kVA</p> <p>2136 kVA 37.4 A 97.85% PF</p> <p>2104 kVA 2849 A 98.63% PF</p>	<p>Losses 15.6KW Rs 960960/year</p>
<p>Transformer Loading and losses with existing Load</p>	
<p>500 MVA_{sc}

</p> <p>33 kV MSEDCCL</p> <p>[25.2 kW, 151 kvar]</p> <p>T1 3150 kVA</p> <p>2717 kVA 47.5 A 99.97% PF</p> <p>2717 kVA 47.5 A 99.97% PF</p> <p>T6 2500 kVA</p> <p>Open</p>	<p>Losses 25.2KW – Rs 1552320/year</p>
<p>Transformer Loading and Losses with New load on Same transformer</p>

Above ETAP simulation results show that

- Present transformer loading is 68% and losses are 15.6KW
- If new load is put on same transformer the loading would be 86% and losses are 25.2KW.
- If new load is supplied through new 2500KVA transformer, the loading of both would be 52 and 42% and the total losses would be 13.98KW This will give saving of about Rs.6.9Lacs/year over option b above.

Proposed solution for accommodating new Load.

- Not to load 3150 KVA transformer any further to avoid fast deterioration of insulation due to handling excessive harmonics and EXTRA loss. *(Kindly note that transformer losses increase in square proportion of current they handle)*
- On any immediate future opportunity 750KW DC drive panel should be replaced with 3 winding (Delta / Delta- Star) transformer and a 12 pulse DC drive to reduce generation of harmonics drastically.
- Plant is expecting addition of another mill with connected load of almost 1200KW. This should be fed with another transformer of 2500KVA and the main motor DC drive should be with 3 winding (Delta / Delta- Star) transformer and a 12 pulse DC drive to reduce generation of harmonics drastically. As shown above this will also ensure reduction in reduction in losses (see table below calculating differential operating cost for both the options.)

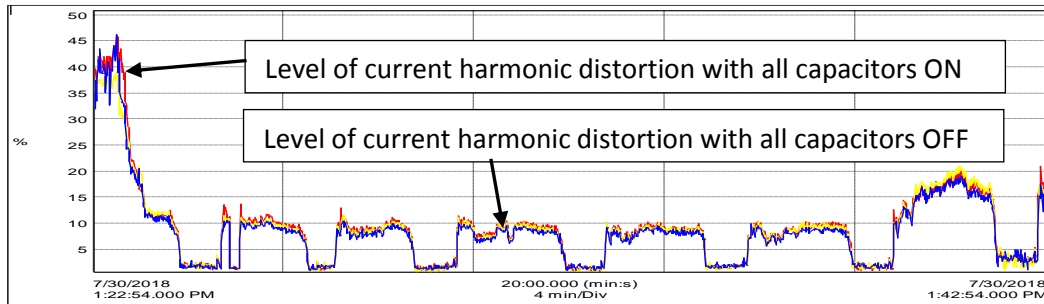
Assessment of harmonics and reactive power at Main incomer – 3150KVA transformer secondary

This indicates resonance due to fixed capacitors.

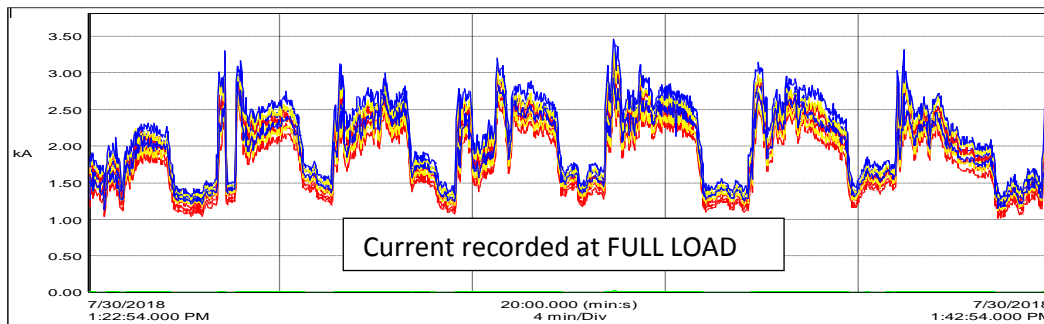
This indicates variation of required kvar as per load. 600KVAR being fixed requirement. Loading cycle is about 2 mins.

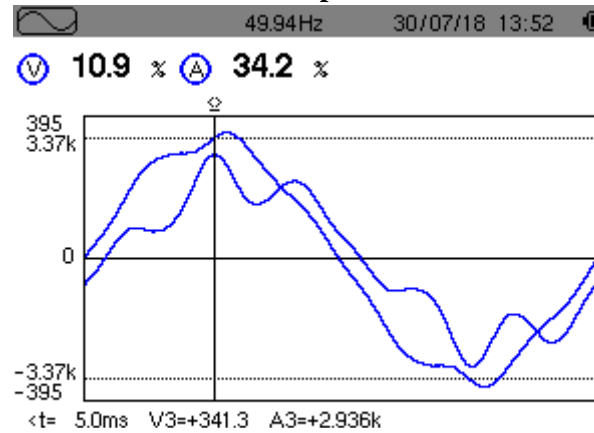
Waveform when Capacitors are ON
